**Subbasins A & E Phase 2
Sanitary Sewer System
Evaluation Survey - 2019**

June 2020

SUBBASINS A & E PHASE 2 SANITARY SEWER SYSTEM EVALUATION SURVEY
City of Sandwich, IL

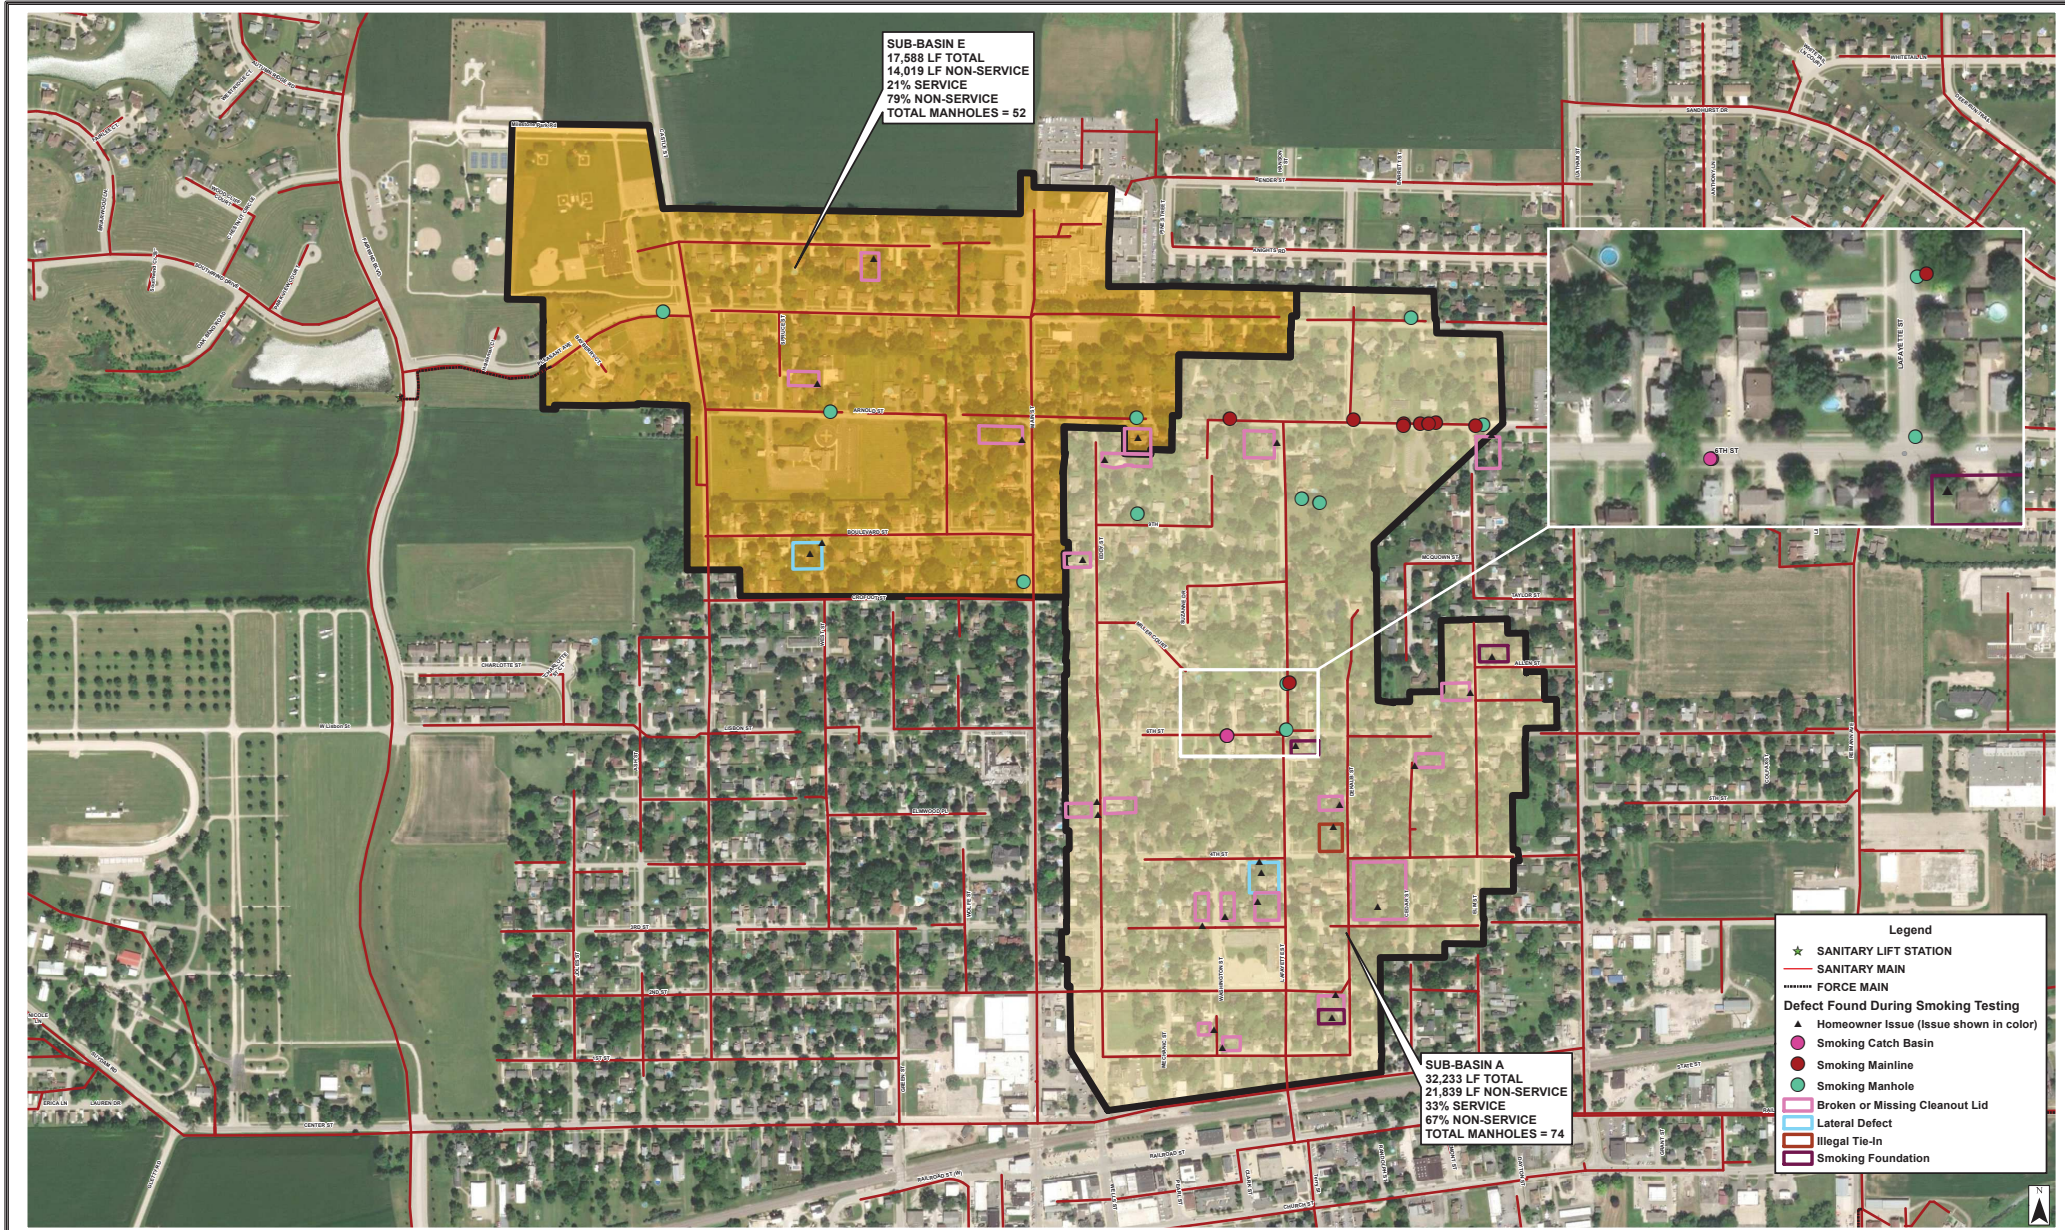
**EXHIBIT 2-1
 SUBBASIN A&E SMOKE TESTING
 DEFECT SUMMARY**

Defects identified during smoke testing were classified by their defect type and the intensity of smoke. During smoke testing, a total of 50 defects were identified in the two tested subbasins. Of these defects, 11 were smoking manholes, 9 were smoking mainlines, 2 were smoking catch basin, 1 was downspout tie-in (illegal tie-ins), 13 were cleanout lid issues, 14 were lateral defects (building-no smoke, smoke-lateral, smoke-foundation). A map of all defects found during smoke testing can be found on Exhibit 2-1.

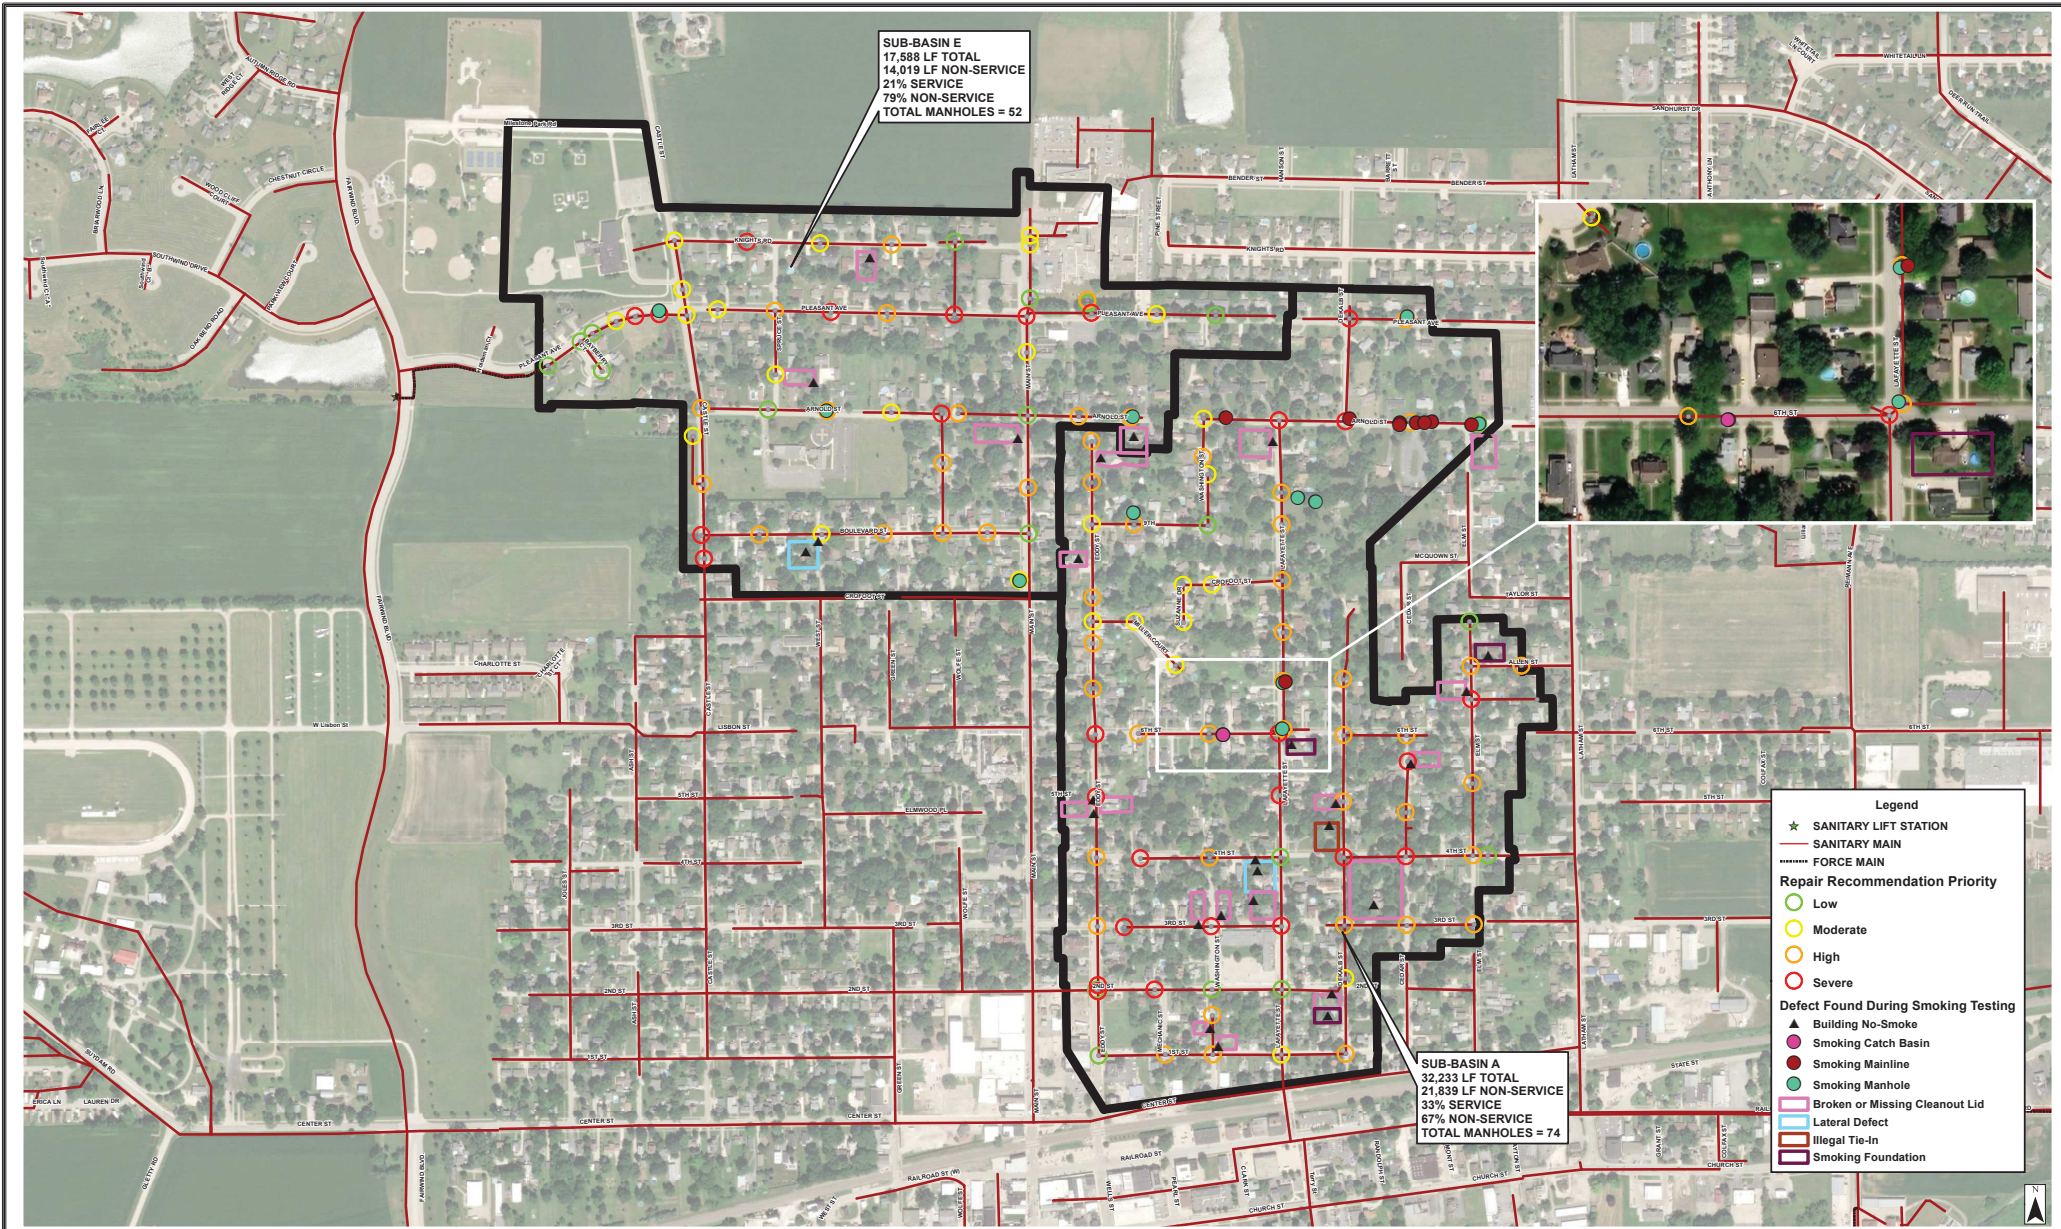
**EXHIBIT 2-2
 SUBBASIN A&E SMOKE TESTING AND
 MANHOLE INSPECTION DEFECT SUMMARY**

Exhibit 2-2 summarizes the manhole inspection and smoke testing results by displaying the defects identified during smoke testing and the manhole rehabilitation priorities in a single exhibit.

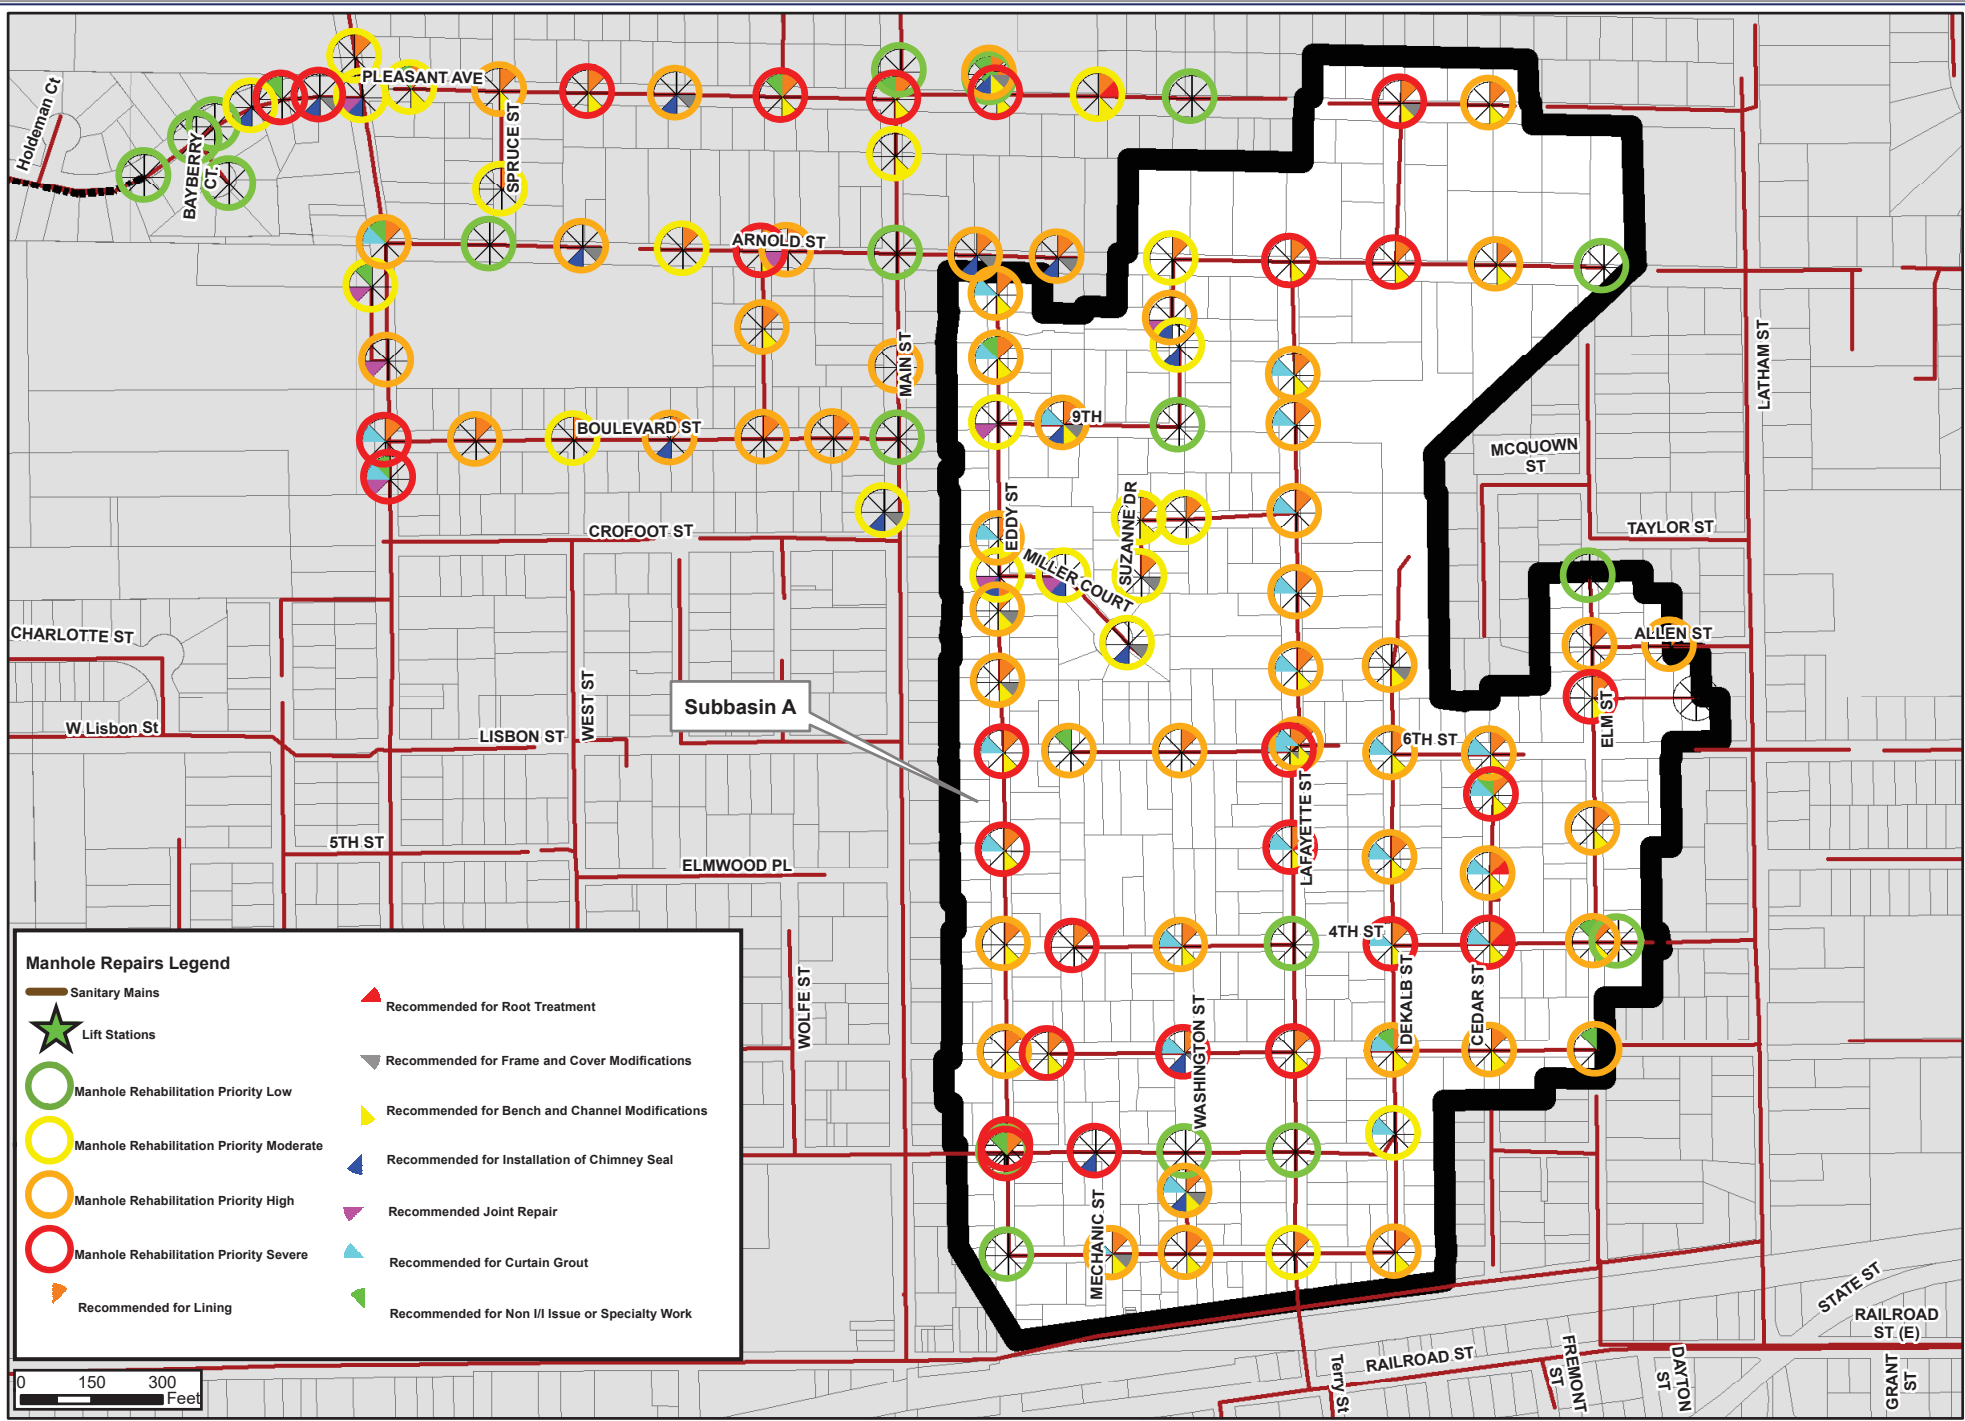
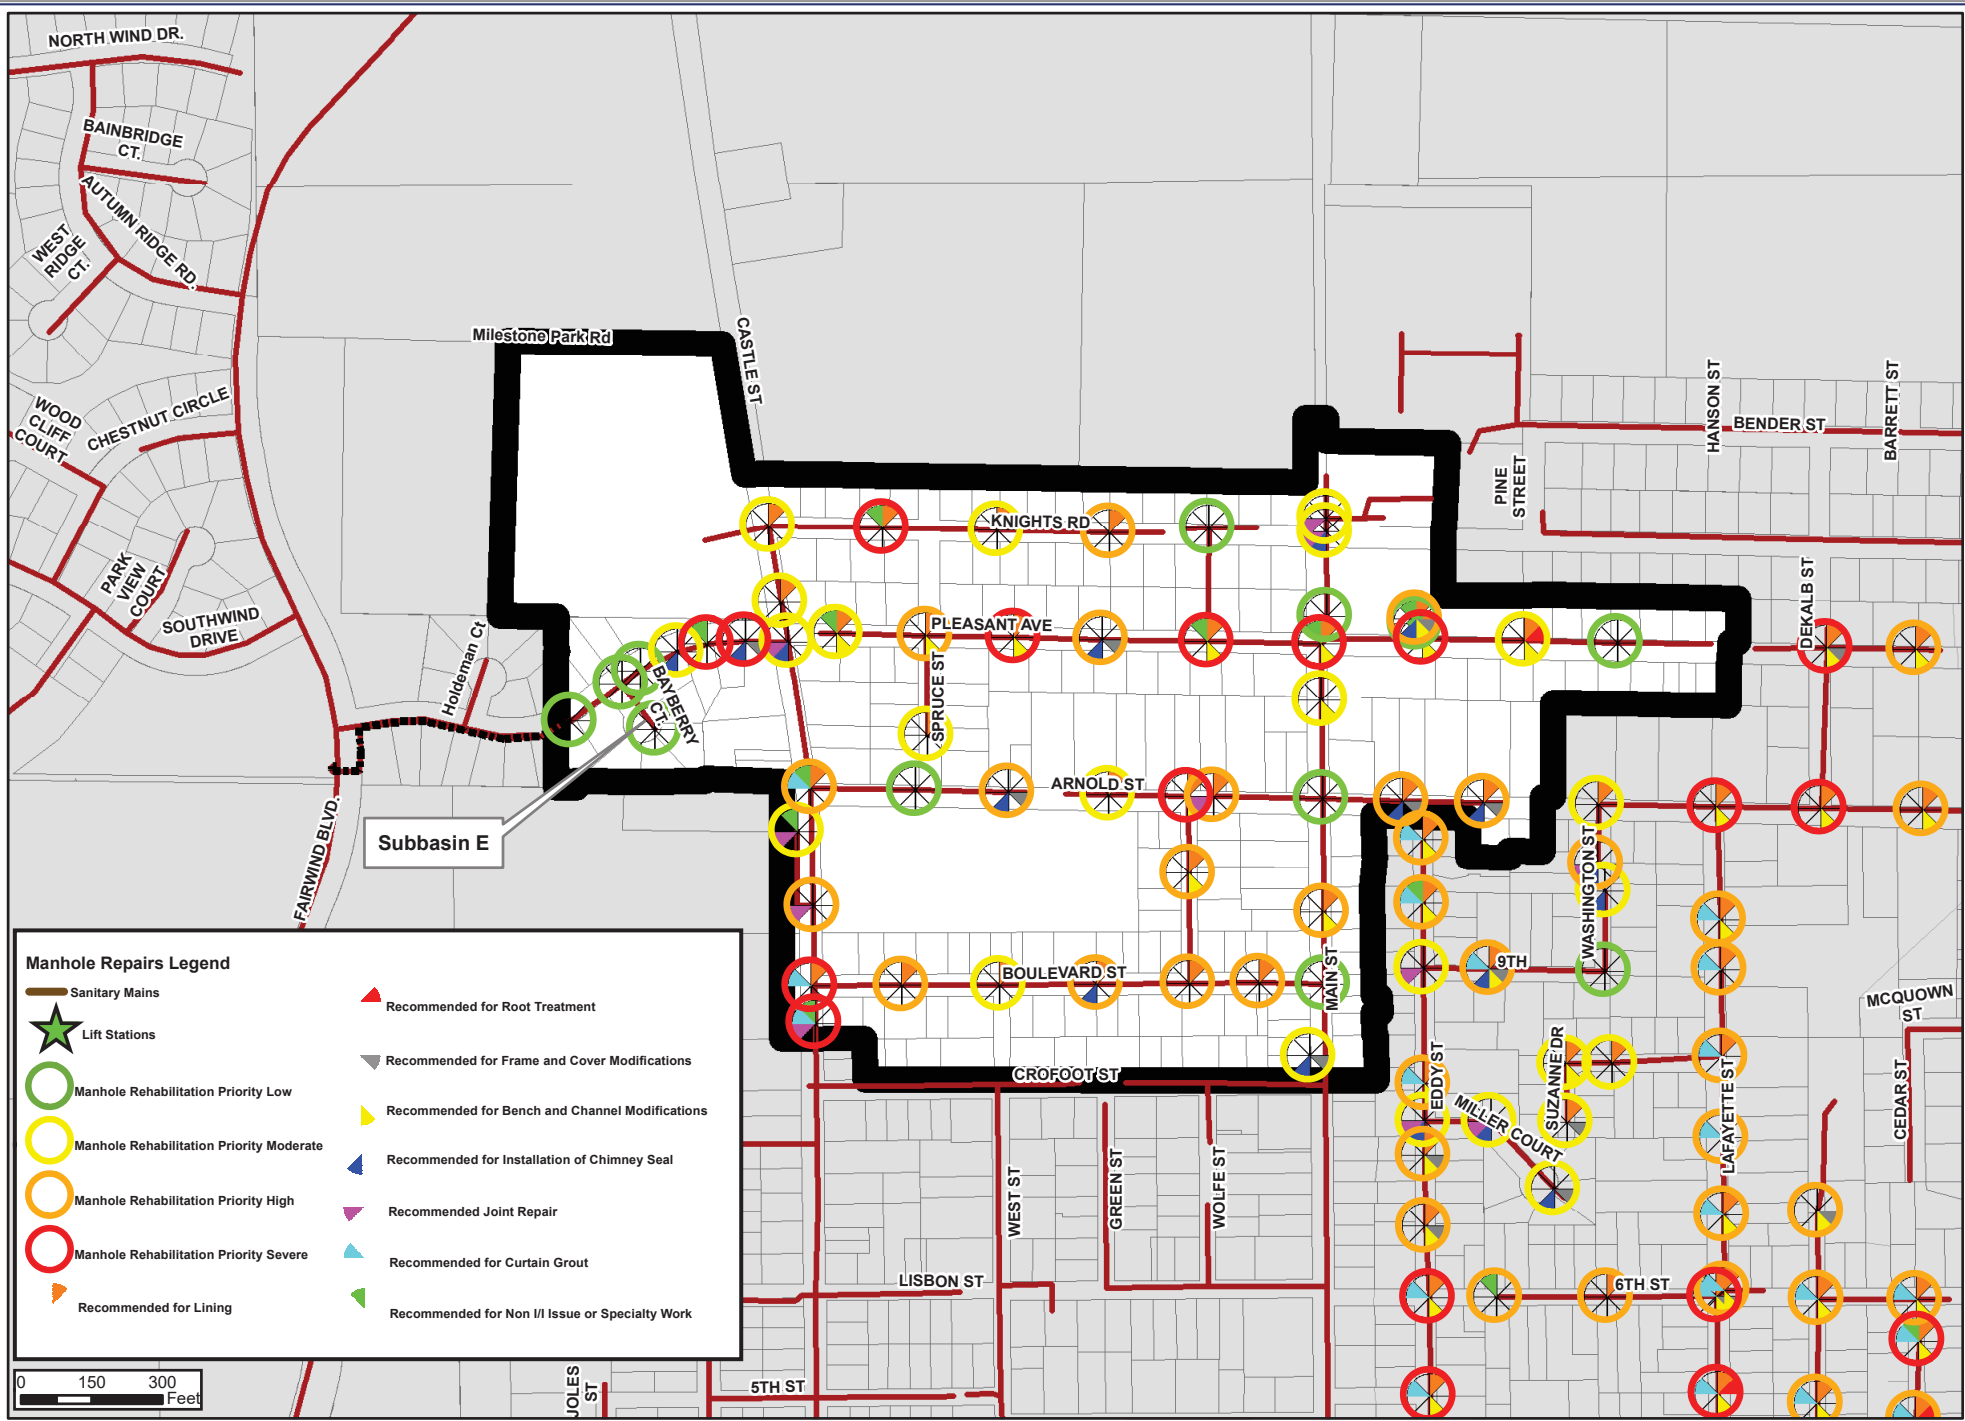
Exhibits 3-1.a-b display the rehabilitation priorities for all surveyed manholes and notes whether each manhole has a recommended rehabilitation method within one of the eight categories by using a 'pie piece' marker for each of the defect categories. Therefore, if a manhole had no rehabilitation recommendations, it would have no 'pie pieces'; however, if a manhole had a rehabilitation recommendation from every one of the eight categories the entire 'pie' would appear.

The manholes in the study area had a wide range of rehabilitation priorities; 28 manholes had a severe rehabilitation priority, 52 manholes had a high rehabilitation priority, 26 manholes had a moderate rehabilitation priority and 20 manholes had no appreciable defects and have no considerable repair recommendations at this time. Exhibits 3-1.a-b. Appendix D shows the manholes and their repair recommendations based on subbasins and rehabilitation priority, Appendix D also includes a list of each recommended defect by manhole.
